Spectrotek Services

Engineering Change Order – PA2-1

Units affected: Serial Numbers 2000 through 2132

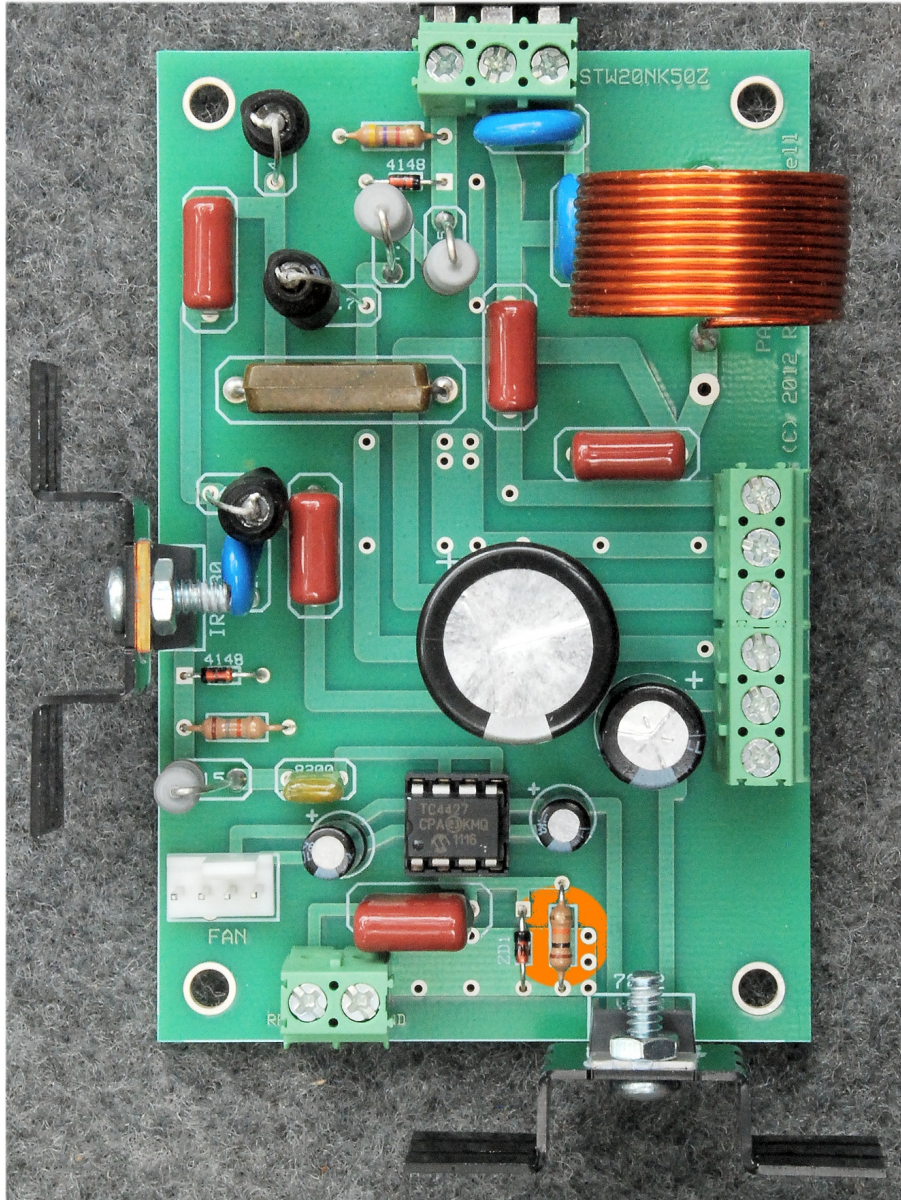
Photo 1

- 1) Random failure of the STW20NK50Z for no apparent reason.
- 2) Overheating or failure of the IRF730 for no apparent reason.
- 3) Unstable waveform on the leading or trailing edge of the modulation square wave.

Manufacturing variations in the input capacitance of the TC4427 MOSFET driver IC may cause an unstable bias condition to exist in the input amplifier of the TC4427. This instability results in a DC level shift, which changes the Schmidt trigger level, causing a series of incorrectly shaped output pulses from the TC4427. These pulses cause excessive current through the IRF730 and excessive drain voltage pulses to appear across the STW20NK50z, causing punch-through failure of the STW20NK50Z.

Please refer to the picture below for the position of resistor R1 which is highlighted in orange.

Replace existing resistor R1, 10,000 Ohms $\frac{1}{4}$ watt with a resistor of 470 Ohms, $\frac{1}{4}$ watt.
