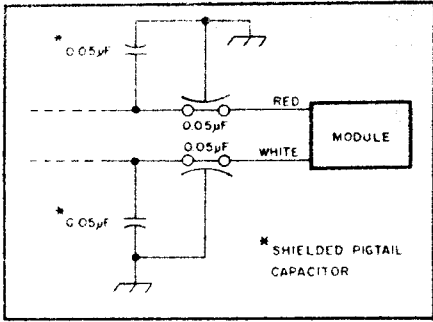
Fig. 13 — When rf from a 130-watt mobile transmitter upset the ignition system in a 1980 Ford police car, Morris Hall, N4MH, installed bypass capacitors as shown in this drawing. The remedy effectively eliminated the problem.

Since I took these corrective measures, the RFI no longer affects the ignition when the transmitter is being operated. — *Morris E. Hall, N4MH*

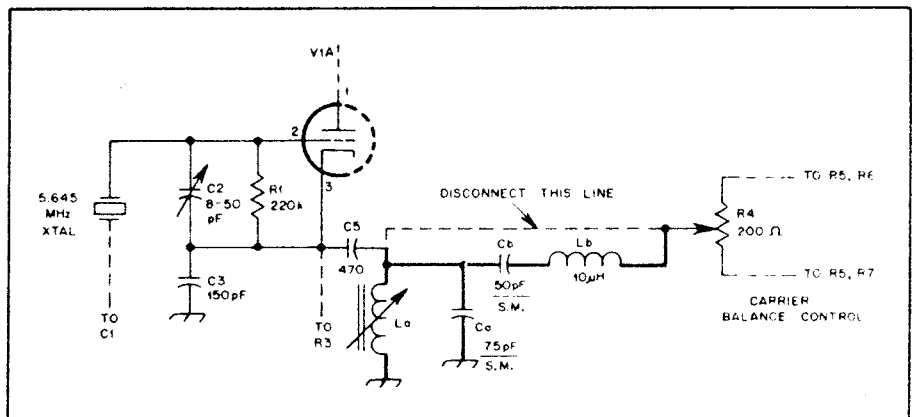
In the Hints and Kinks section of June 1979 *QST*, J. H. Mehaffey described a TVI problem with his TR-4 very similar to one that had plagued me for some time. I have a Drake T-4XB. His simple and successful modification of the TR-4 to clear up the harmonic output of the 9-MHz carrier oscillator clearly pointed the way for me.

Unlike the TR-4 with a 9-MHz oscillator, the T-4XB carrier oscillator is at 5.645 MHz, so different values of components are required to make the fix. In my case, those used were "junk box" values, ones at hand close enough to what seemed to be needed. Fig. 14 is drawn in a manner to match that of the Drake manual.

Fig. 14 — The W6HB anti-TVI modification for the Drake T-4XB. Heavy lines show added circuitry.

There is sufficient chassis room for the few required parts under and around R4, the carrier-balance potentiometer of the T-4XB. L_a , the slug-tuned coil, is easily mounted in the extra hole of the left-rear chassis apron. With the adjustment screw on the outside, access to it is easy, although this is a seldom-needed tuning adjustment. L_b and the two capacitors are supported by a small double tiepoint and the respective leads. The short ground connections are made to the socket frame of V1.

I also took Mr. Mehaffey's suggestion regarding linearizing the final by disconnecting C53 and C58, the 470-pF cathode bypass capacitors of the 6JB6 output tubes. L_a can be peaked with a dip meter. Touch-up tuning for maximum drive, as shown by increased final-amplifier plate current, should follow. To complete the adjustment, realignment of the carrier oscillator ought to be carried out using the procedure in the Drake manual.

TUNE L_a TO 5.645 MHz + RETUNE OSCILLATOR.

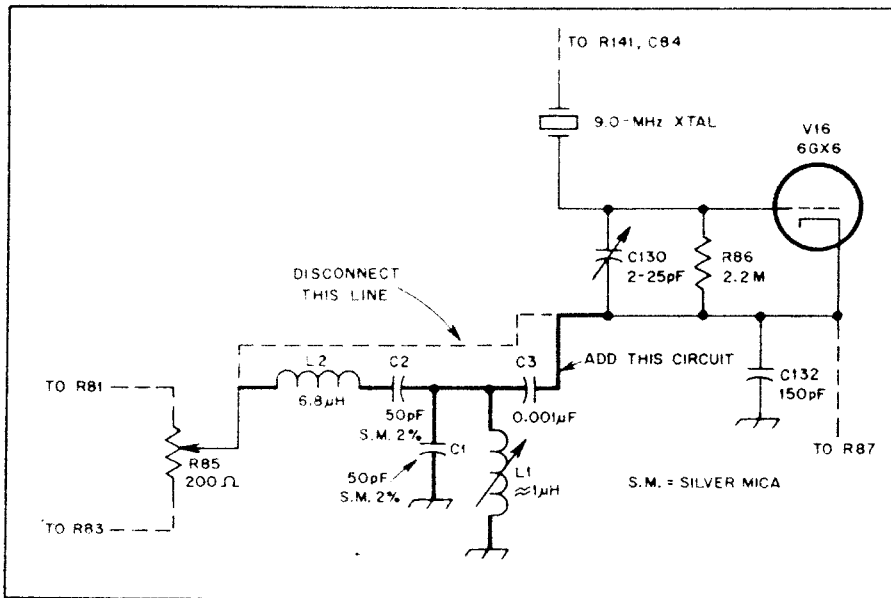
Fig. 1 — This filter circuit is designed to eliminate TVI from Drake TR-4 transceivers. The heavy lines show circuit changes. With the aid of a loosely coupled dip meter placed near L1, tune L1 to resonate at 9.0 MHz. Tuning is not critical.

peared on TV channel 2 when my TR-4 was operating on 14 MHz and on channel 4 when the transceiver was on 21 MHz. Use of a low-pass filter at the output of the transmitter and high-pass filters on the TV sets partially eliminated the TVI. Further steps had to be taken for a complete cure.

Cause: Strong radiation on the 2nd, 3rd and 4th harmonics was noted. A low-pass filter effectively reduced interference received via the transmitting antenna. With the help of a search loop and spectrum analyzer, I established that undesirable harmonic radiation was coming from the chassis. Further investigation disclosed the presence of relatively strong harmonics at the grids of the 6JB6 final amplifiers. These unwanted signals passed right through [for perhaps *around* — Ed.] the 9.0-MHz sideband crystal filter. Correcting this condition and eliminating harmonic content in the final amplifier by adjusting the amplifier for proper linearity brought the matter to a successful conclusion.

Cure: Oscillator distortion was corrected by installing a 9.0-MHz parallel-resonant circuit (Fig. 1) from the wiper of the carrier balance potentiometer to the cathode circuit of V16. This circuit is tuned to approximately 9.0 MHz with the aid of a dip oscillator. Final adjustment is

accomplished by observing an oscilloscope connected to the grids of the 6JB6 amplifiers while tuning for maximum amplitude. The transmit-gain potentiometer should be set in the linear region (about the nine o'clock position) for this adjustment. Realignment of the 9.0-MHz oscillator according to instructions in the Drake manual is also required.

Linearizing the final amplifiers is done simply by providing for additional cathode degeneration. To do this merely remove the 470-pF capacitors from pin 3 of the 6JB6 amplifiers. The power reduction is not noticeable.
